## Palmyra Palm and the Protection of Landslide along the Canal

Sugar palm tree has been considered as a valuable multipurpose tree for several centuries for the production of food and construction materials that will produce income for rural communities. Sugar palm, also known as Palmyra palms, are economically useful and widely cultivated, especially in South –East Asia. The Palmyra palm tree has long been one of the most important trees of Cambodia and India. In Thailand, the sugar palm tree (*Borassus flabellifer*) plays an important role. It provides different products such as juice, sugar, leaves, timber, fruits, underground seedlings, and roots. As the sugar palm tree has a deep root system (up to 15 m), it can be used to control landslides or soil erosion on the river edge, if it is planted along the roadside or canal as Thailand has numerous canals, both natural and man-made, used for irrigation of agricultural cultivation and boat transportation, which was a major travel method in the past. Additionally, landslide along canals is a common problem in all regions of the country, a problem which the government needs to address with a huge budget for the construction of conc

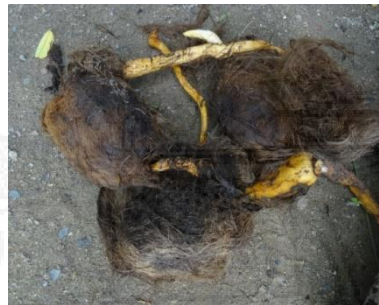
**Figure 2** Sugar palm root system

Apart from the benefit of the sugar palm tree for pharmacological aspects, some literature reviews reveal that their root system has long hairy roots and side roots based on the trunk (Sukamaluddin et al., 2016). And as the sugar palm tree has a deep root system (up to 15 m), it can be used also to control erosion (Borin, 1996a). Furthermore, Jana & Jana (2017) reported that sugar palm trees, when grown on banks of water bodies, can prevent soil erosion and help to recharge the water table.

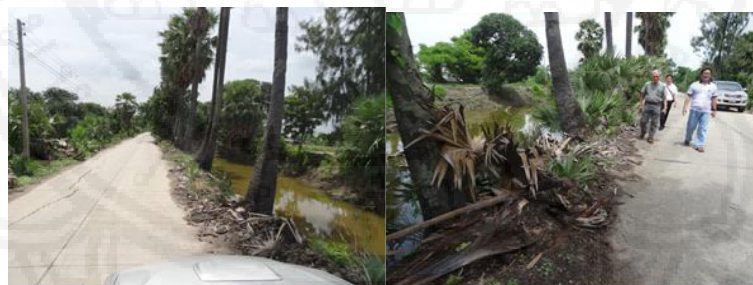
**Figure 3** Sugar palm tree planted along the canal in Pathum Thani, Thailand

Moreover, sugar palm trees planted on banks of canal and river can also prevent soil erosion because sugar palm root systems can hold the soil in place to protect the soil from raindrop splash impact and overland flow as shown in Figure 3.

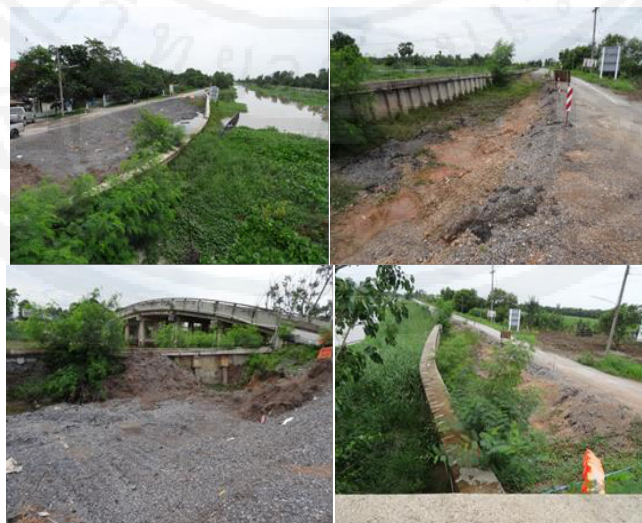
**Figure 4** Concrete fence for canal landslide protection in Thailand

Concrete pavement revetments are cast in place on a prepared slope to provide canal bank protection and it is a type of rigid revetment that does not conform to changes in bank geometry due to removal of foundation support, or outward displacement by hydrostatic pressure, slide action, or erosion of the supporting embankment at its ends. Concrete pavement revetments are also among the most expensive stream bank protection designs. In the past, the concrete pavement has been best utilized as a subaqueous revetment (on the bank below the water surface) with vegetation or some other less expensive upper-bank treatment (Colorado Department of Transportation, 2004). Figure 4 shows the construction of a concrete fence along the canals in Thailand to prevent landslide and soil erosion.

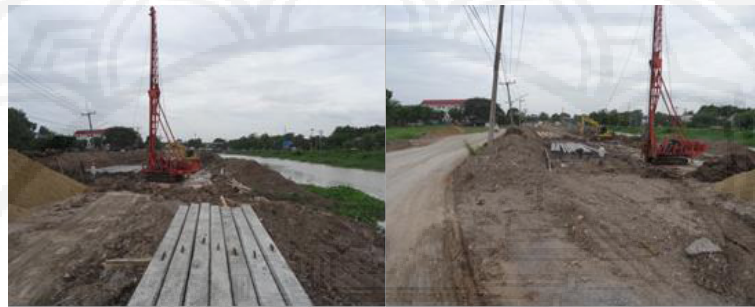
**Figure 4** Construction of concrete fence for canal landslide protection

Since a lot of canal and river of Thailand has many landslide problems, it needs construction of the concrete fence for protecting the erosion. Some studies of the concrete construction project are conducted to prevent the landslide along the canal in Chumphon province that has the length 220 meters of wall, which requires a budget for construction as 12,470,000 Baht as given in Figure 5 (Ministry of Agriculture and Cooperatives, 2014). So, the construction of concrete walls to prevent erosion on the canal banks, although popular, is very expensive in construction cost. Therefore, it should be replaced with another cheaper and natural solution with less cost through adoption of vegetative measures like sugar palm cultivation, replacing the concrete fence to save the construction costs and at the same time lower maintenance requirements in the long term.
